RCRA Compliance Evaluation Inspection Report

ExxonMobil Paulsboro Lube Plant
1001 Billingsport Road
Paulsboro, New Jersey 08066
EPA ID No.: NJD986629178

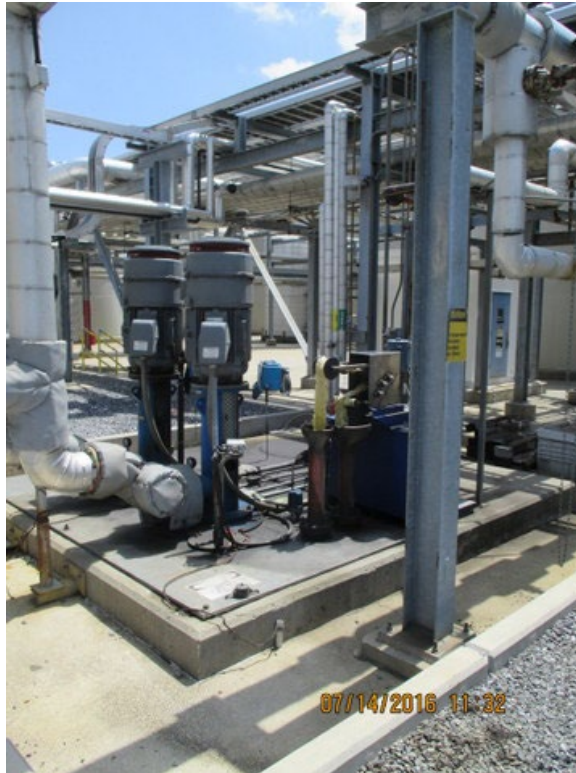
The floor drains beneath the truck loading rack drain to Tank 106, which is an accumulation tank for slop oil. Oil from Tank 106 is processed into bar and chain oil for chainsaws. Other floor and sewer drains within the process areas of the facility drain to an oily water sump (see Photo 1) that discharges into PBF Energy's oily water sewer across the street. Liquids in this sewer are ultimately treated before being discharged to the Delaware River.

Photo 1. Sump and Pumps That Send Oily Water to PBF Energy's Wastewater Treatment Plant

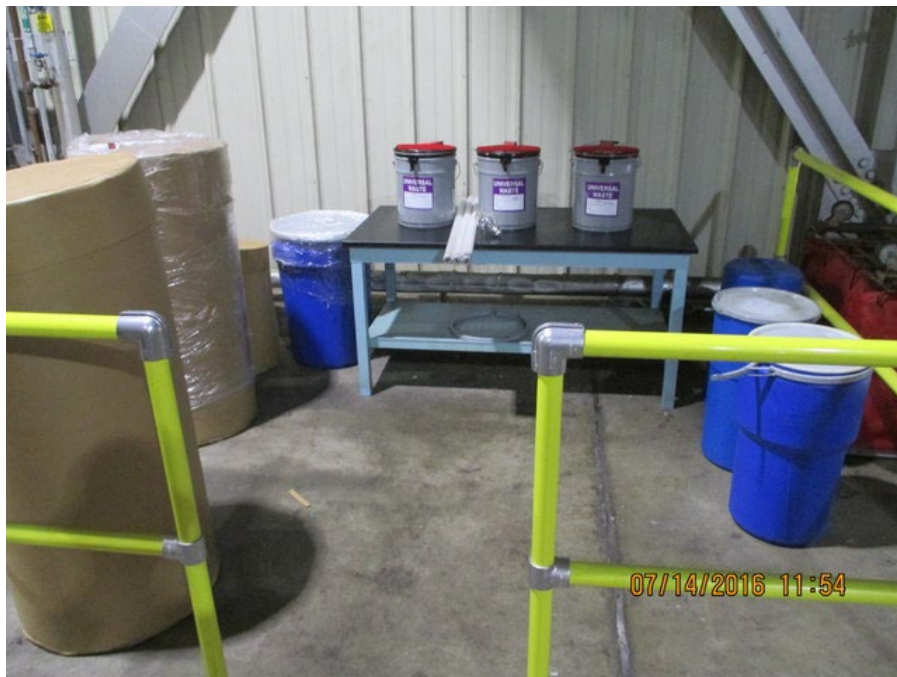
Photo 2. Universal Waste Lamps Sitting on Table in Universal Waste Area

During the visit to the universal waste area, the inspection team observed three used fluorescent lamps and one high intensity discharge bulb sitting out on a table.

Universal waste lamps in the universal waste area were not in properly labeled, closed containers².

Universal waste lamps should be placed in containers that are dated; closed; and labeled "Universal Waste – Lamps," "Waste Lamps," or "Used Lamps." In addition, the date the first used lamp is placed in a container should be recorded to verify that the lamps do not remain in storage for more than one year. Regulatory Citations: 40 CFR 273.13(d)(1), 40 CFR 273.14(e) and 40 CFR 273.15(c).

² ExxonMobil staff placed the universal waste lamps into properly labeled, closed containers during the inspection.

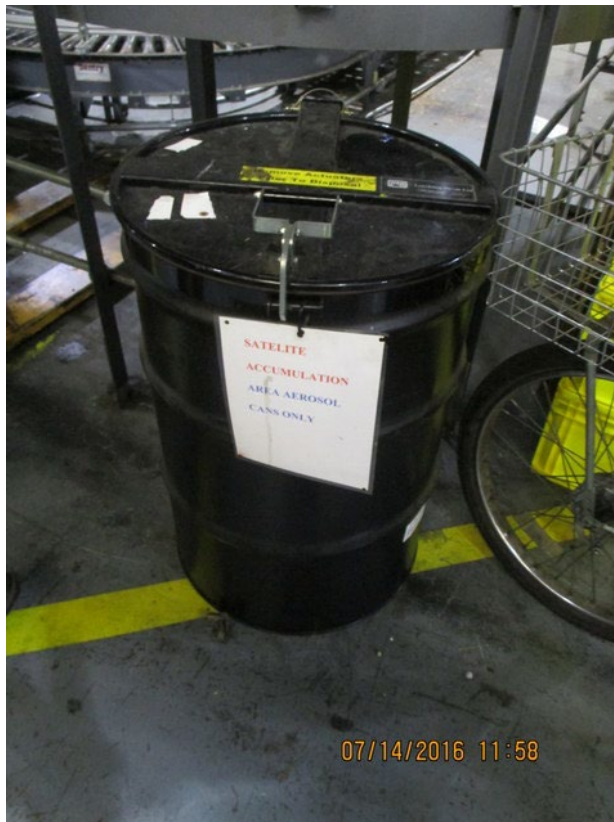
Photo 3. Satellite Accumulation Area for Aerosol Cans

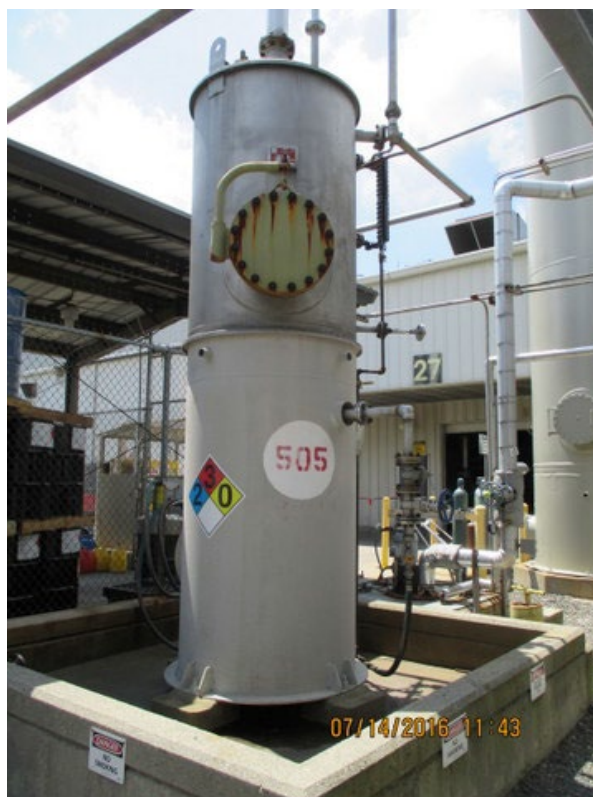
Photo 4. 500-Gallon Waste Solvent Storage Tank

Facility personnel noted that the spent solvent tank typically contains approximately 85 percent heptane and a small amount of chlorobenzene. These solvents originate in the laboratory during their glass cleaning and sample analysis activities. The tank is inspected daily, has a pressure vacuum vent that controls its emissions, and is emptied at least every 180 days.

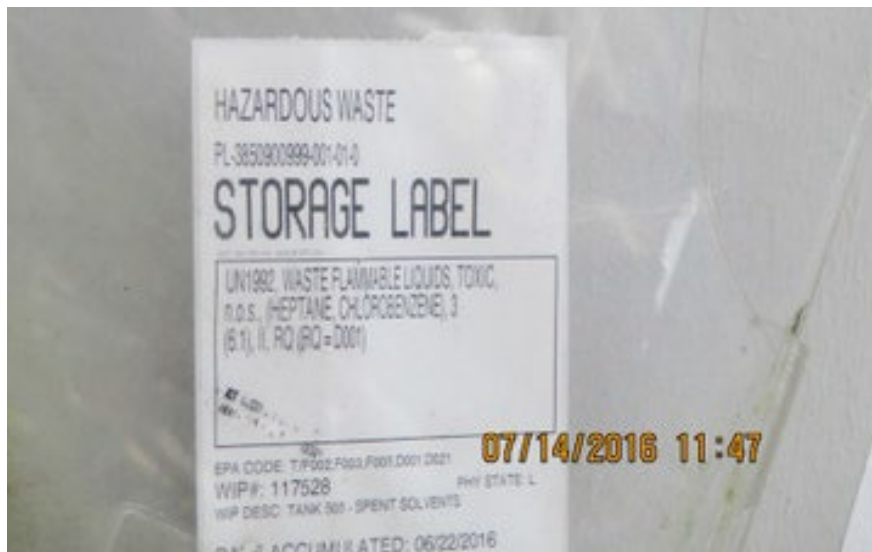
Photo 5. Label on 500-Gallon Waste Solvent Tank

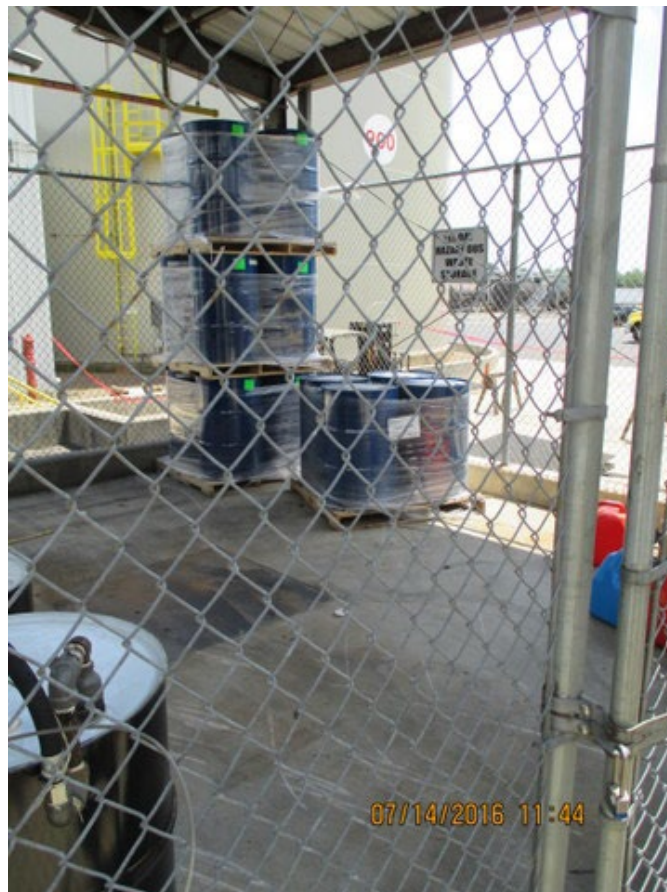
Photo 6. Less-Than-180-Day Waste and Flammable Products Area

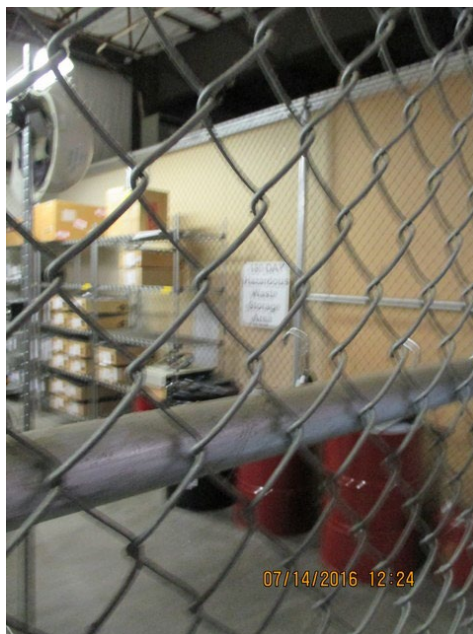
Photo 7. Less-Than-180-Day Waste Area Near Lab (Black Drum Was Unlabeled and Contained Hazardous Waste Rags)

During the visit to the laboratory sample cage, the inspection team observed a partially full hazardous waste drum with no label.

A 55-gallon drum in the laboratory sample cage contained hazardous waste rags, but did not have a label¹.

Each container should be labeled "Hazardous Waste" or with other words that identify the contents. Regulatory Citation: 40 CFR 262.34(c)(1)(ii).

¹ ExxonMobil staff labeled the container during the inspection after the inspection team identified the issue.

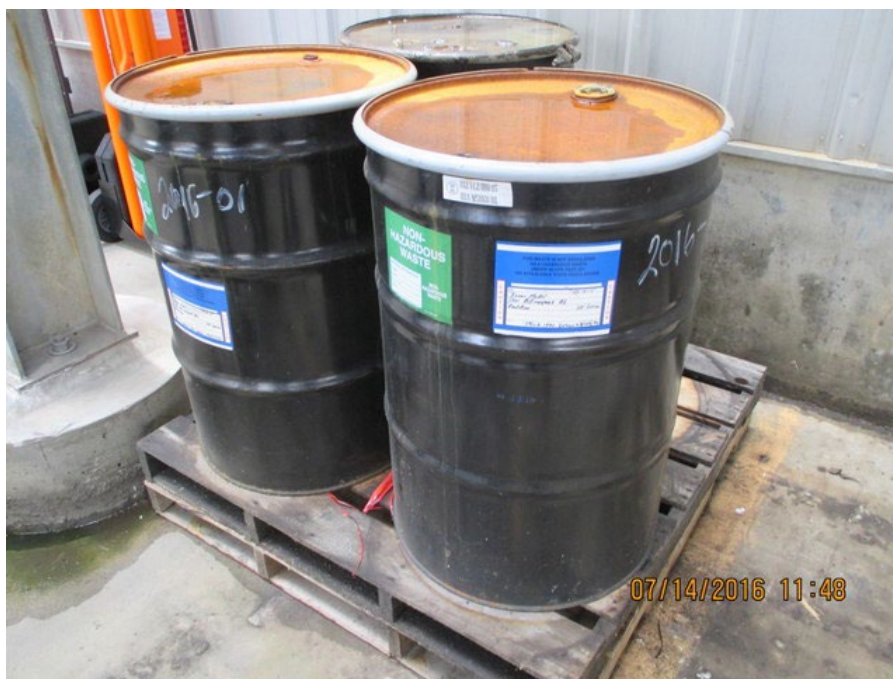
Photo 8. Nonhazardous Waste Storage Area
